SURVEY OF MOISTURE
LEVELS IN ATTICS

Final Report

Buchan, Lawton, Parent Ltd.
5370 Canotek Road
Ottawa, Ontario

BLP File No. 2497
March, 1991

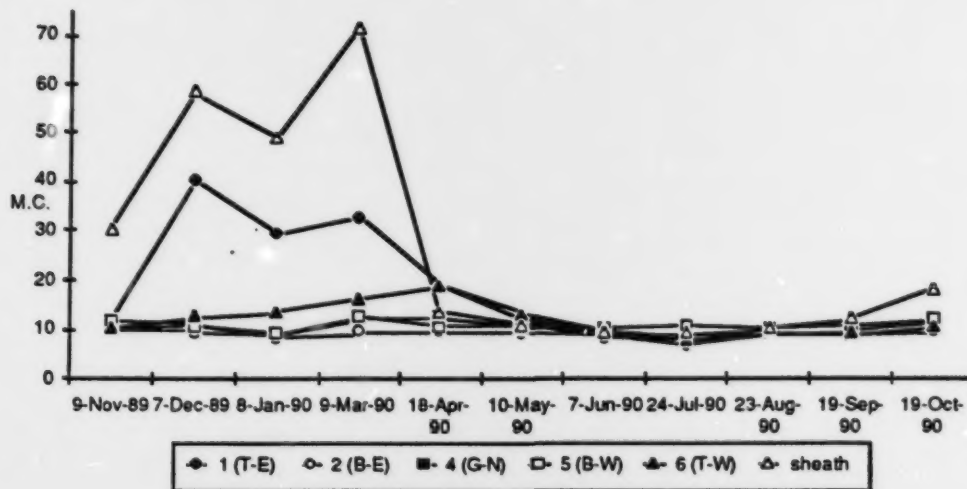
Figure 3.2 Typical Moisture Content, Wet Attic, Seasonal Profile

The test group of homes was divided into three categories according to the wetness monitored. 'Wet' attics were considered to have moisture content values above 30 per cent in the sheathing and at least one of the monitored framing members. 'Dry' attics were categorized as having all moisture content values around or below 20 per cent. It was found that three of the fifteen Ottawa area homes and one of the Maritime homes fell into the wet category. These are Homes O-1, O-12, O-13, M-2. Five out of fifteen of the Ottawa area homes and one of the Maritime homes fell into the dry category. These are Homes O-3, O-5, O-9, O-10, O-14 and M-5.

The third category consists simply of those attics neither categorized as wet nor dry. Figure 3.2 contains a sample of moisture curves typical of the wet category and Figure 3.3 contains a sample of the dry category.

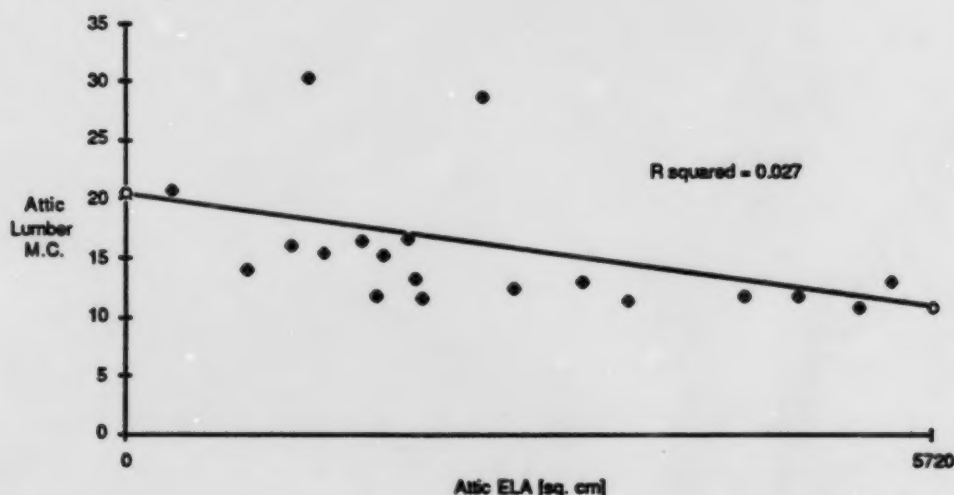
Figure 4.4 Attic Moisture Content versus Attic Equivalent Leakage Area

In Figure 4.4, the plots and line fits of the attic moisture content versus attic ELA showed a positive correlation. This plot indicated that, in this survey, attic wetness decreased with increasing attic Equivalent Leakage Area. The four highest points correspond to the four "wet" attics (in descending order: O-1, O-13, M-2, O-12).

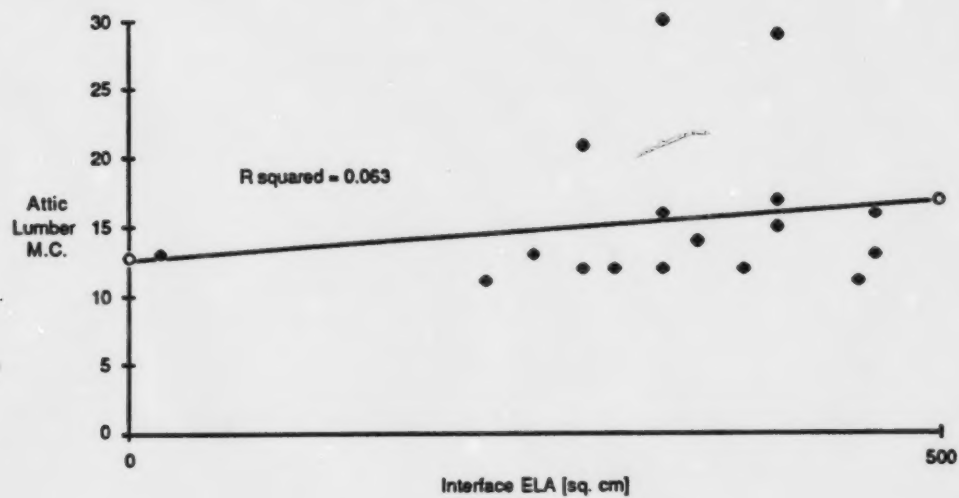
Figure 4.5 Attic Moisture Content versus Interface Equivalent Leakage Area

The scatter plot and regression line of maximum moisture content versus interface Equivalent Leakage Area is presented in Figure 4.5. Although the interface flows posted in Table 3.3 show a large degree of scatter, this is largely reduced when this flow is expressed as a fraction of total attic air change. This normalization allows comparison of interface leakage flows among houses. In Figure 4.5, a plot and regression of maximum moisture content versus interface leakage flow is provided.
